## Hydraulics Details & Steering

07/12/2011

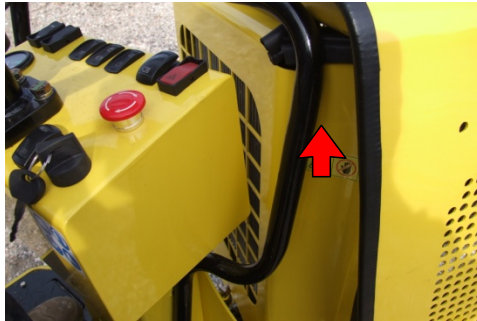
### Problem-1: Structural problems

Solution: In this present prototype machine we cannot do much on this problem. This happened because of slight misalignment while welding the structure; we have made further changes to avoid this problem in future.

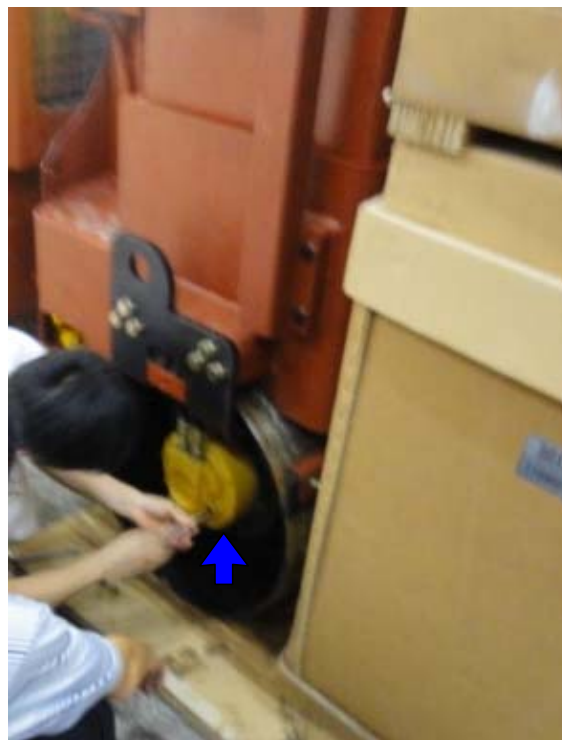
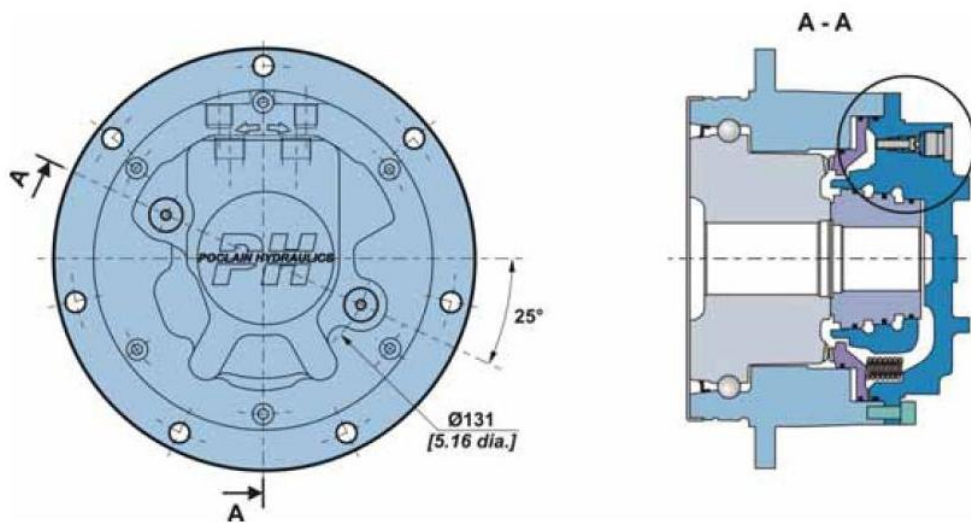
If anything happens to this motor, the machine cannot be towed. For that you may have to release the break mechanically. The procedure for doing this is described below.

Release the spring by unscrewing the bolt. Which shown in round.

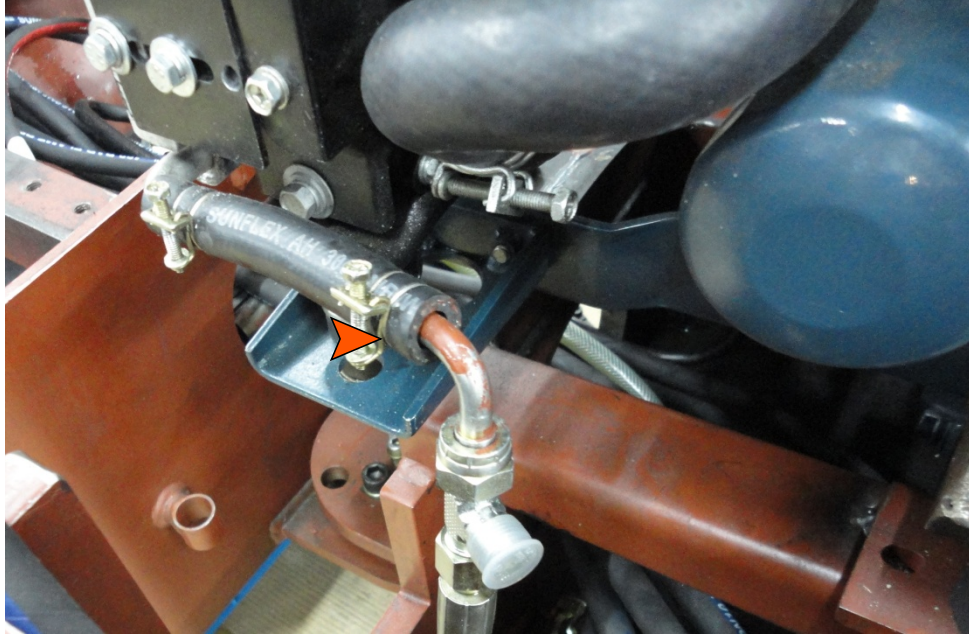
Sometimes there may be a problem of leaking from the inlet connector to oil cooler. This may be because of loose connection to oil cooler. But the possibility for this is very rare.

For the next series of machine we will be replacing this with hydraulic connectors.
