## Hydraulics Details & Steering

07/12/2011

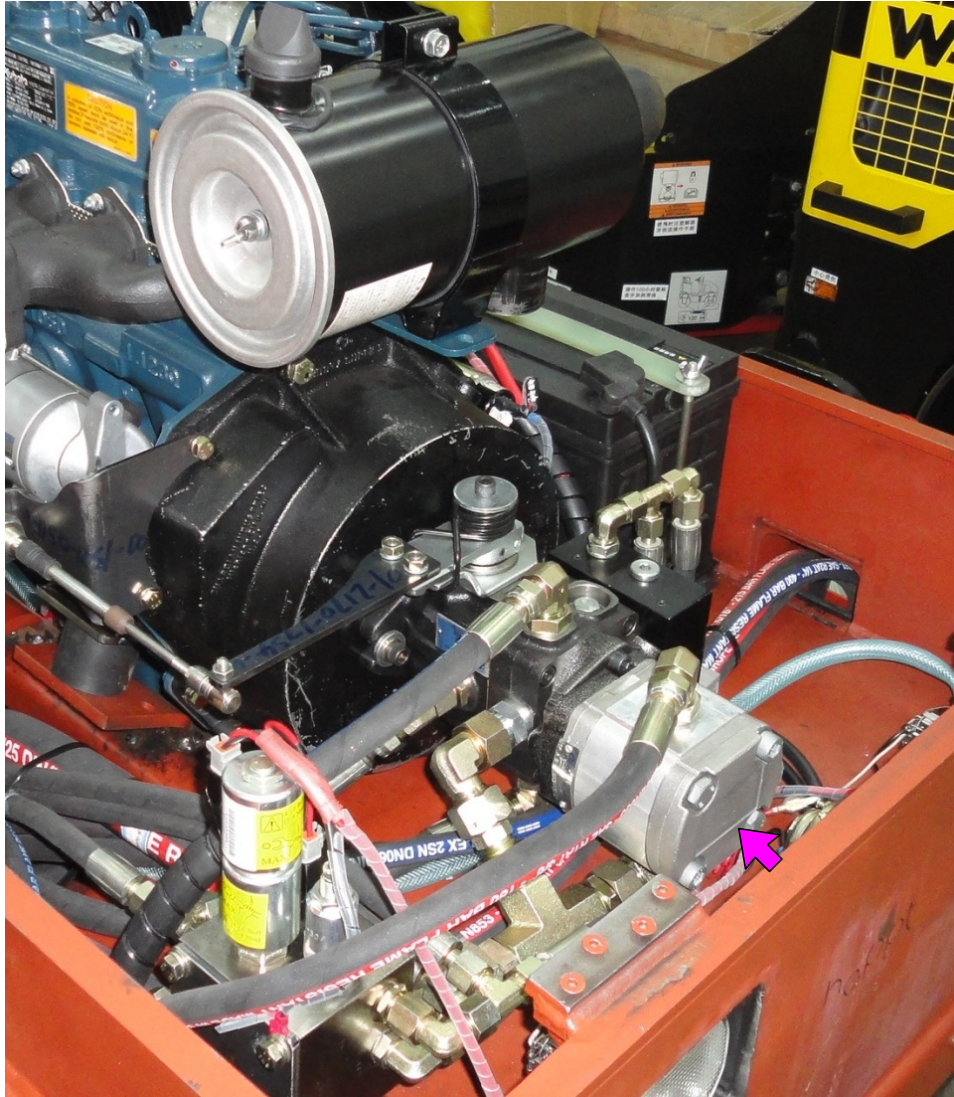
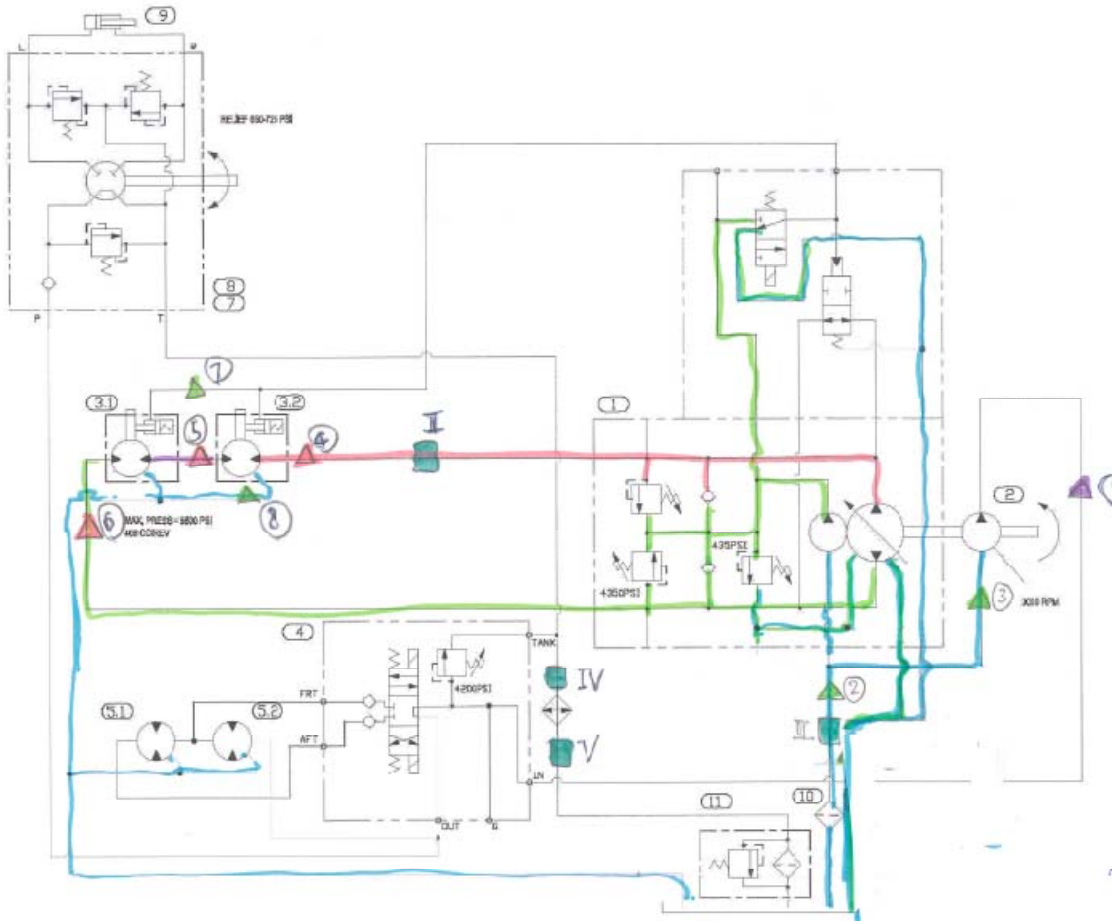
The lines marked in Green and red is called **main loop**. This drives the entire machine. (Please find the attached PDF file for reference).

In this circuit we are not expecting any problems. Because we already checked and tested the system. And as of now cannot modify anything here. Probability of hydraulic leakage is also very rare.

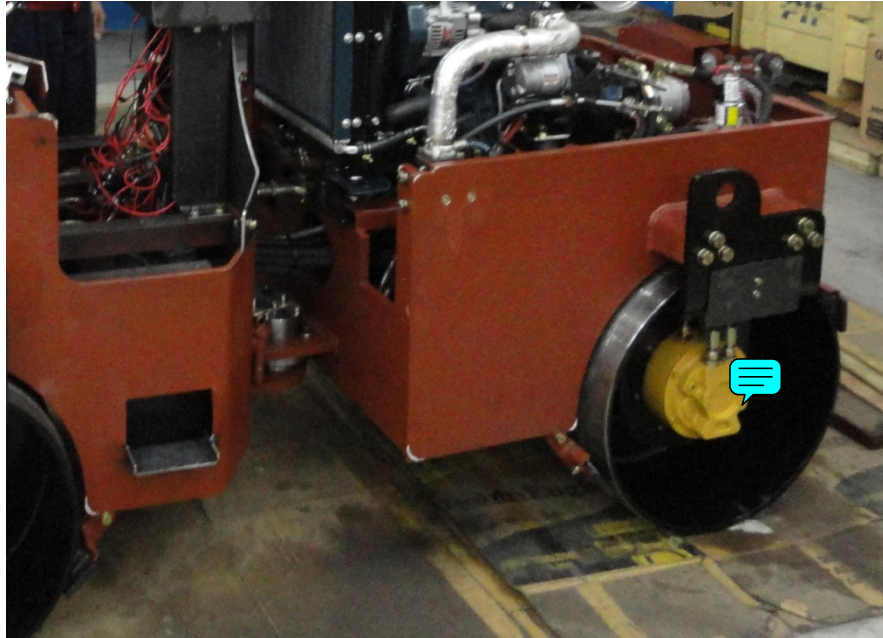
The Drive motor, which drives the machine, is from PH.

From the manufacturer and our own study shows almost all companies uses this motor for this class of machine. Which indirectly implies that we may not be facing much problem from this motor.

If anything happens to this motor, the machine cannot be towed. For that you may have to release the break mechanically. The procedure for doing this is described below.
